**Sand Point
Potential Partnership Study**

**Building No. 18
Fire Station**

Sand Point Potential Partnership Study

Building Data Sheet

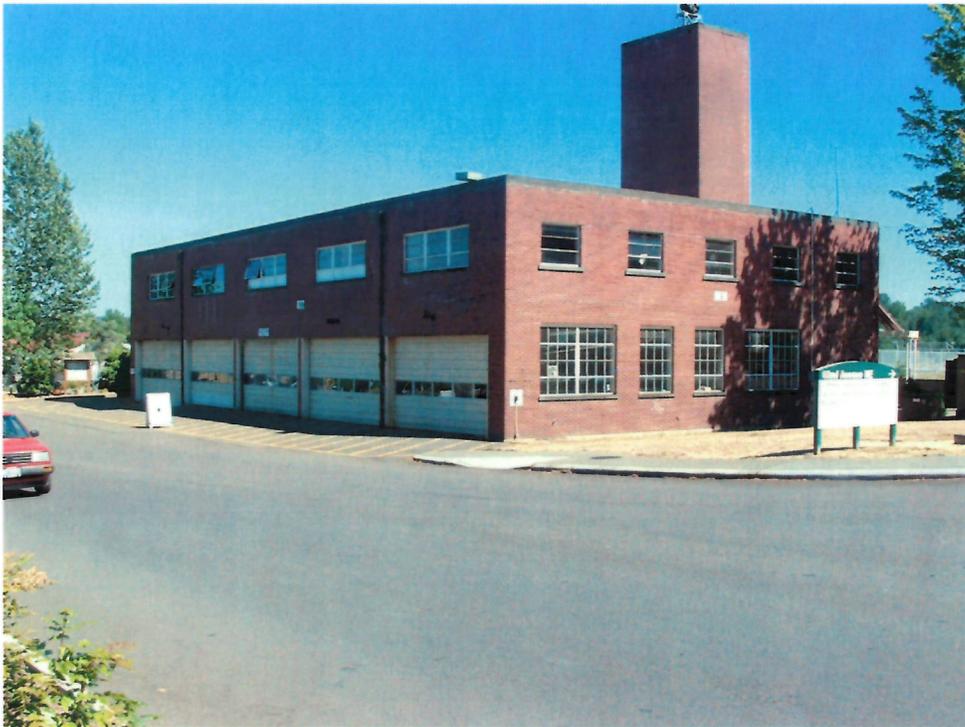
This building suffered a recent fire, and has considerable smoke damage on the 2nd floor. Firefighters cut numerous holes in the roof to vent the fire. Major deterioration to the roof structures in this area has occurred.

The basic exterior of the building appears in good shape, with the exception of the parapet precast, the roof, and the shed on the very east end of the building. Roofing will require replacement, as will a significant portion of the roof structure and sheathing on the N. ½ of the roof. Doors and windows are in generally decent condition, needing cleaning and painting. The exterior sheathing on the "shed" and on the south face of the second floor appears to be the suspect asbestos board.
